ZUNI HOUSING AUTHORITY

GIS Housing Needs Assessment & Inventory

FINAL REPORT

August 2018

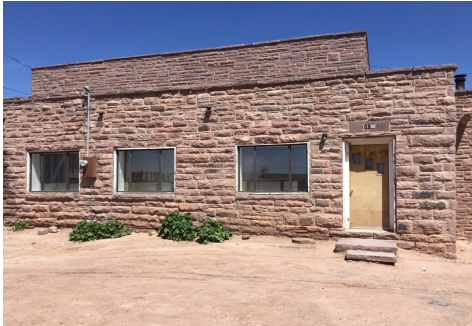
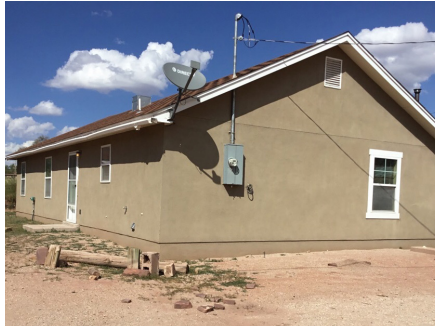
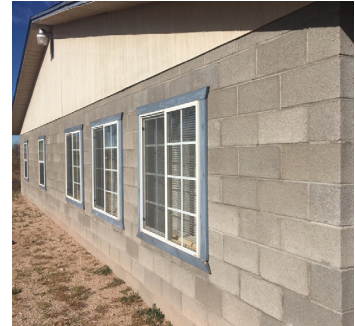
No wall deficiencies

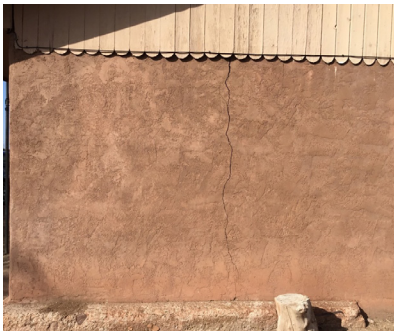
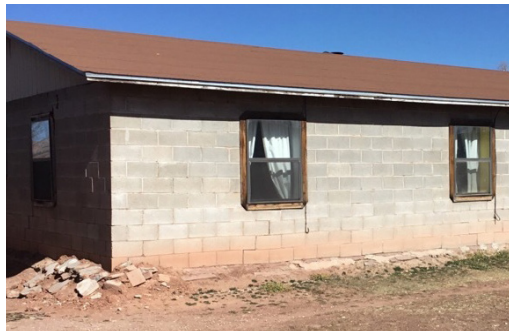
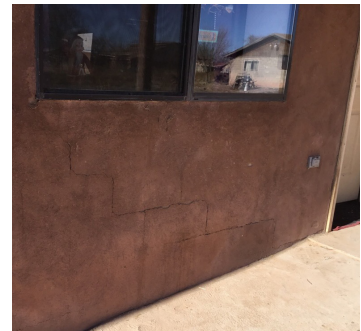
Minor wall deficiencies

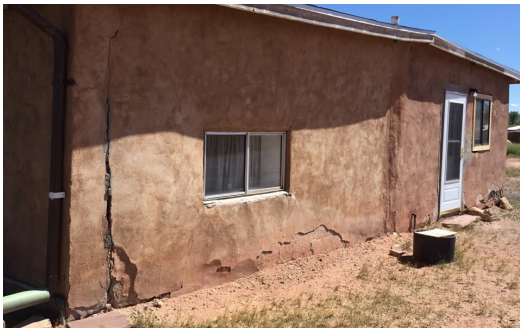
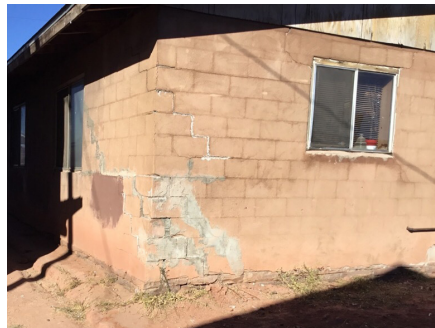
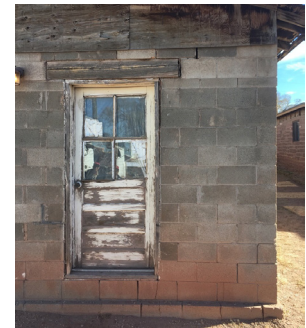
Moderate wall deficiencies

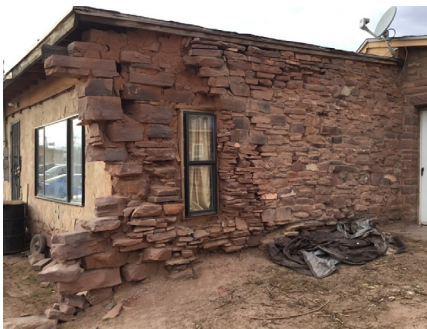
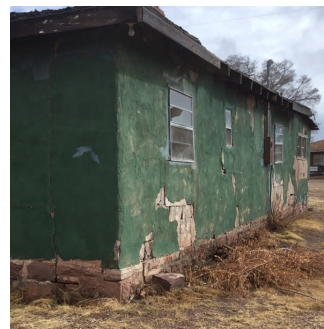
Major wall deficiencies

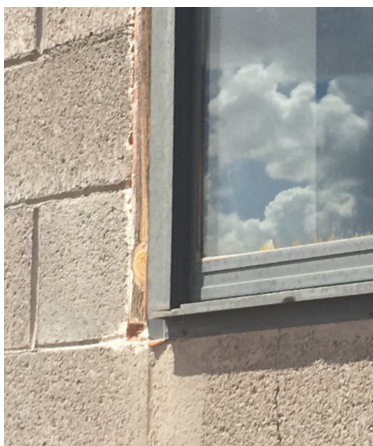
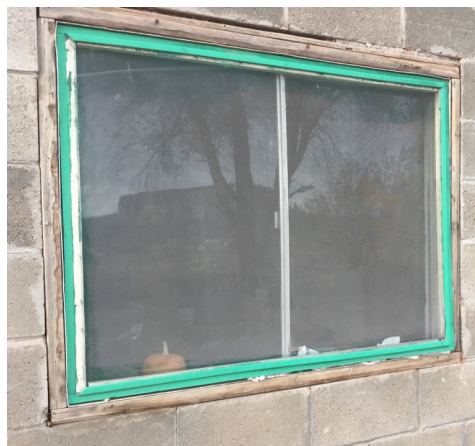
Images of CMU constructed homes with window winterization needed. This unfinished condition provides an opportunity for water infiltration and mold.

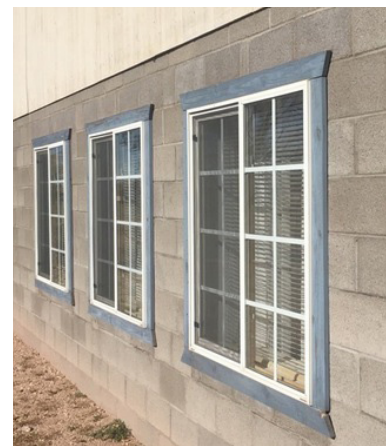
Home with finished window winterization.

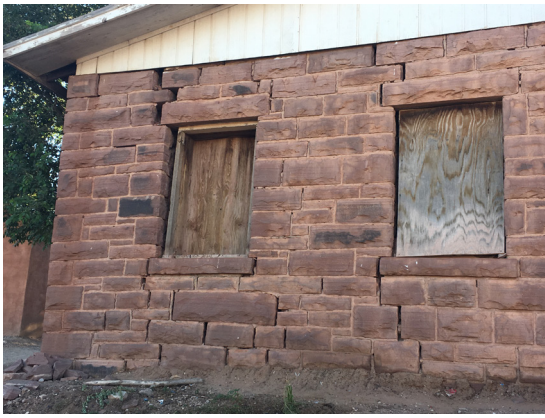
Stone masonry home in Middle Village showing signs of structural settlement. Major cracks (+1/2 inch) visible from exterior.

We suggest that the engineering study develop a range of standard foundation details for a variety of soil conditions in different areas of the reservation. These details could be provided to homeowners constructing their own homes as well as to the groups constructing the Shalako homes. While it is probably too ambitious that specific foundations would be engineered for each new home at Zuni, the creation of foundation guidelines, including standards for slab thickness, foundation depth, and reinforcement would be beneficial to the tribe. Exactly what an engineer can prescribe without site-specifics will need to be determined.

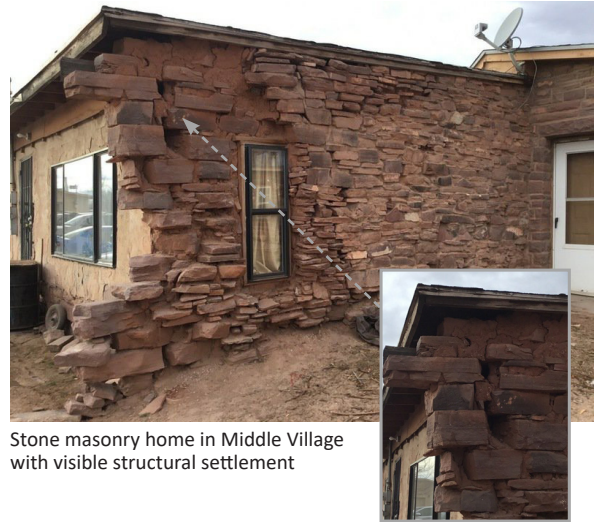
Stone masonry home in Middle Village with visible structural settlement

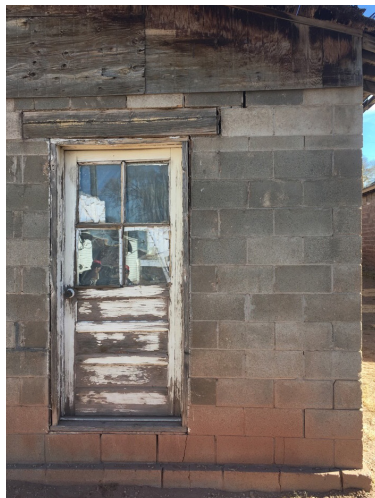
CMU constructed home with visible foundation settlements from exterior corner. Back door no longer operable from wall settlements.

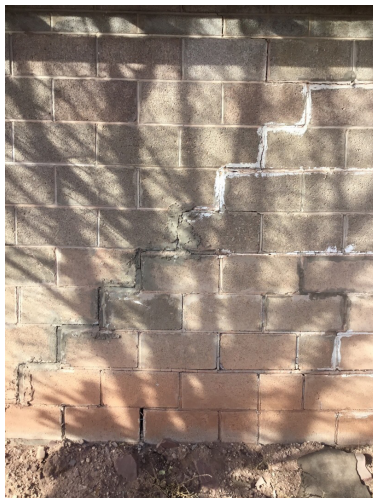
CMU constructed home with visible foundation settlements from exterior. This type of wall patching is common in homes experiencing settlement issues.

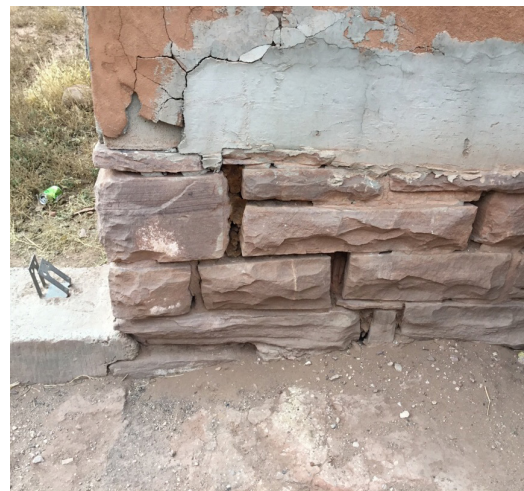
CMU home (partially constructed with stone) with visible foundation settlements from exterior corner.
