ZUNI HOUSING AUTHORITY

GIS Housing Needs Assessment & Inventory

FINAL REPORT

August 2018

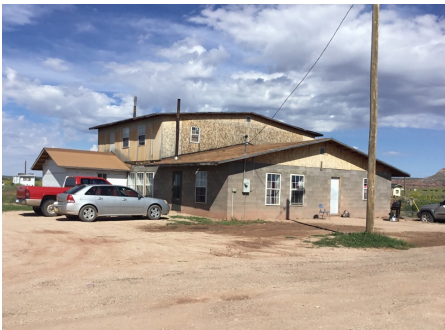
CMU with No finish, OSB/ PWD exposed

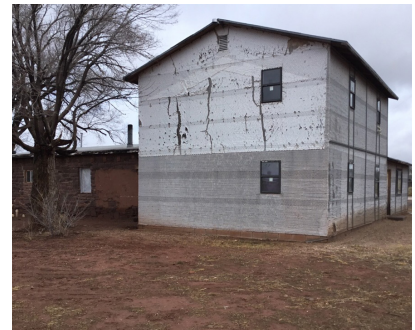
**Cement stucco incomplete/
building wrap exposed**
